8th Generation Intel[®] Core[™] Processor Families

Specification Update

*Supporting 8th Generation Intel[®] Core[™] Processor Families,
Intel[®] Pentium[®] Processors, Intel[®] Celeron[®] Processors for U
Platforms, formerly known as Whiskey Lake and Amber Lake
4-Cores*

Revision 004

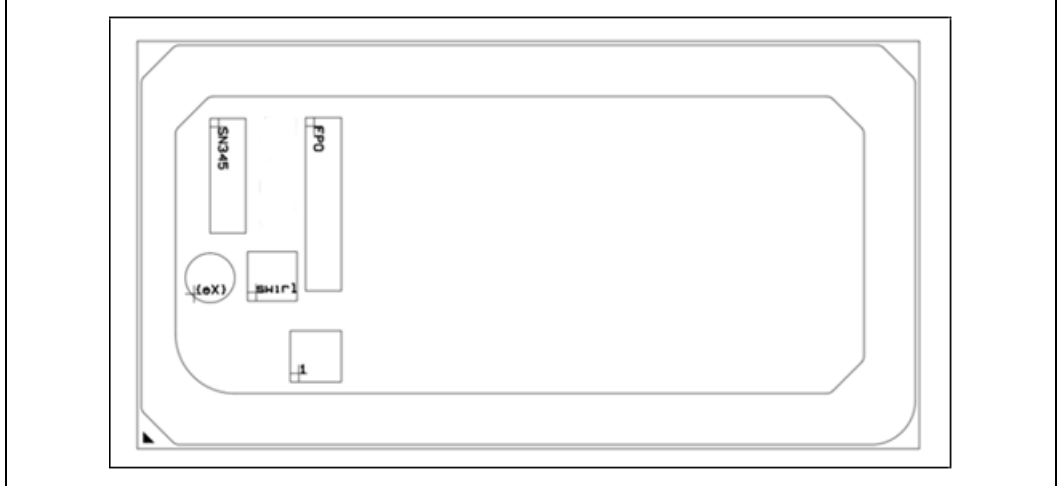
Figure 1. U-Processor Line Multi-Chip Package BGA Top-Side Markings

Pin Count: 1528 and Package Size: 46 mm x 24 mm

Production (SSPEC):

- FPO: FPOxxxxx
- {eX}
- SWIR1: Intel® logo

Note: "1" is used to extract the unit visual ID (2D ID).

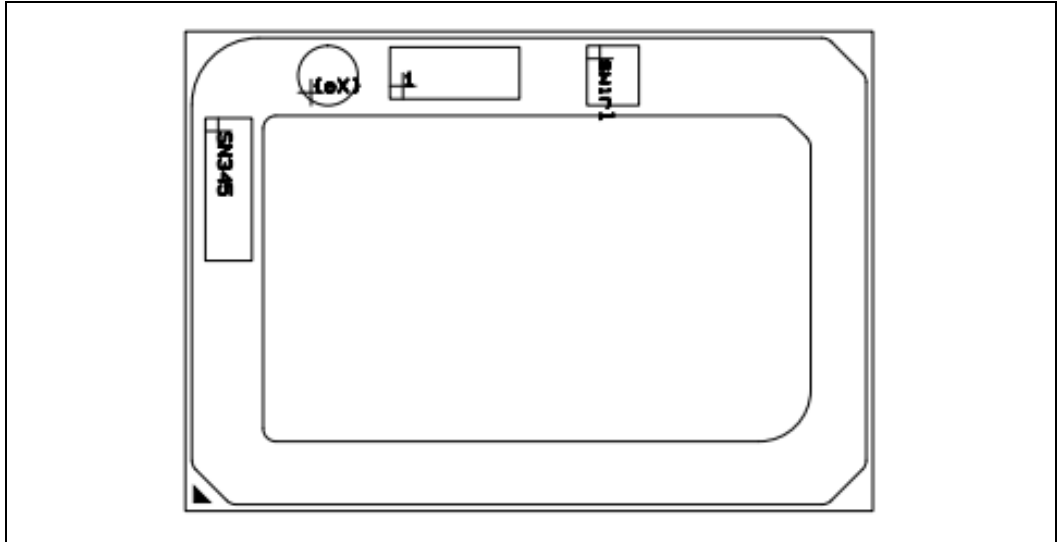
Figure 2. Y-Processor Line Multi-Chip Package BGA Top-Side Markings

Pin Count: 1377 and Package Size: 26.5x18.5 mm

Production (SSPEC):
