10th Generation Intel® Core™ Processor

Specification Update

Supporting 10th Generation Intel® Core™ Processor Families, Intel® Pentium® Processors, Intel® Celeron® Processors for U, H, and S Platforms, formerly known as Comet Lake

Revision 010

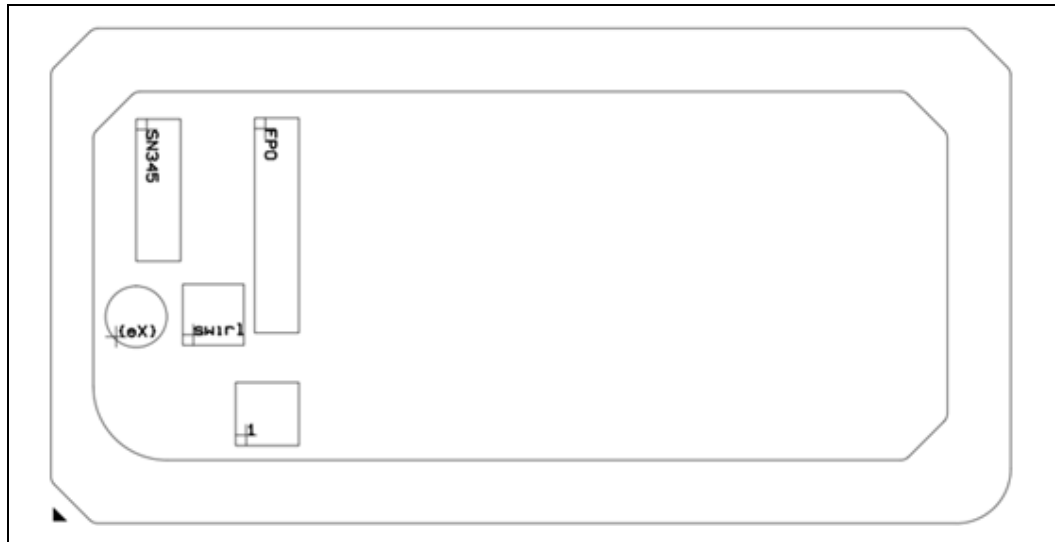
Figure 1. U-Processor Line Multi-Chip Package BGA Top-Side Markings

Pin Count: 1528 and Package

Size: 46 mm x 24 mm

Production (SSPEC):

- FPO: FPOxxxxx
- {eX}
- SWIR1: Intel® logo

Note: "1" is used to extract the unit visual ID (2D ID).
