Intel® 82574 Family Gigabit Ethernet Controller Specification Update

*February 2020
Revision 4.1*

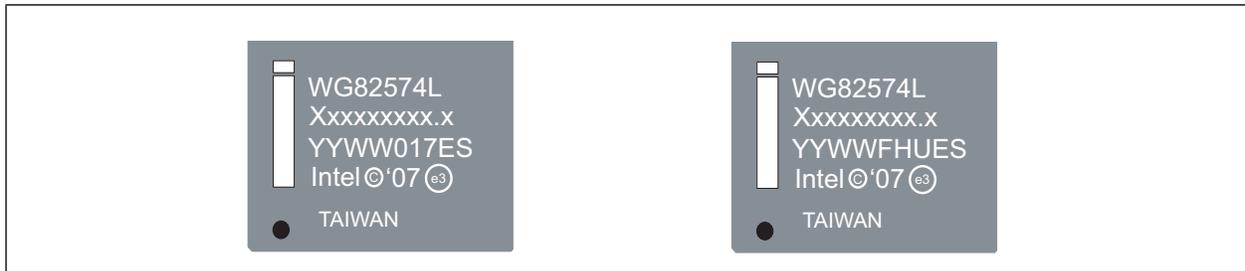
Figure 1. Engineering Samples Top Marking Example With Identifying Marks

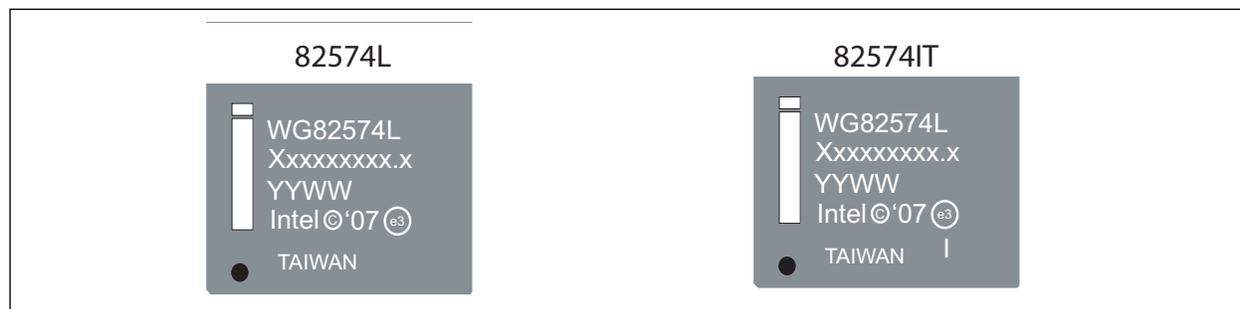
Figure 2. Production Top Marking Example With Identifying Marks

1. See [Figure 2](#).
