# Intel<sup>®</sup> Xeon<sup>®</sup> D-2100 Processor Product Family

**Specification Update**

**Order Number: 338854-012**

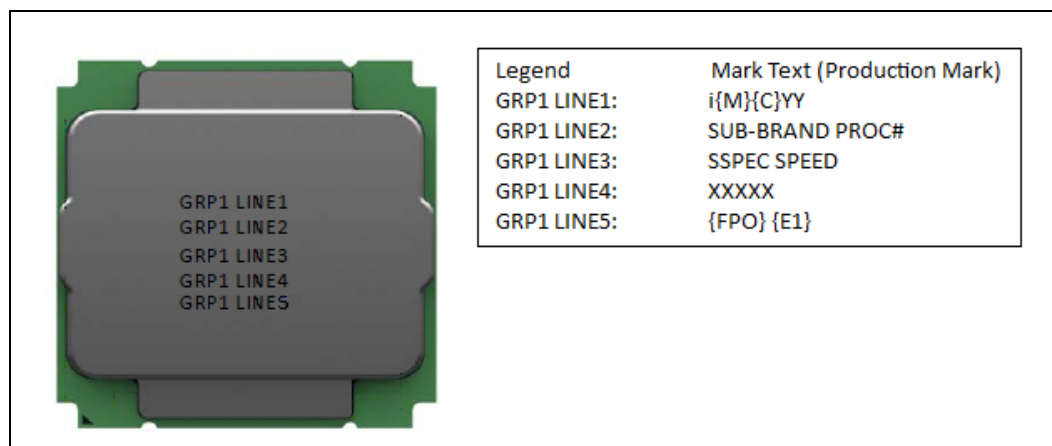
**Figure 1. Intel® Xeon® D-2100 Processor Product Family Top-Side Markings (Example)**

The Intel® Xeon® D-2100 Processor Product Family stepping can be identified by the following component markings.
