# **Intel<sup>®</sup> Ethernet Controller X710/ XXV710/XL710**

**Specification Update**

***September 2020***

Revision 3.9  
331430-019

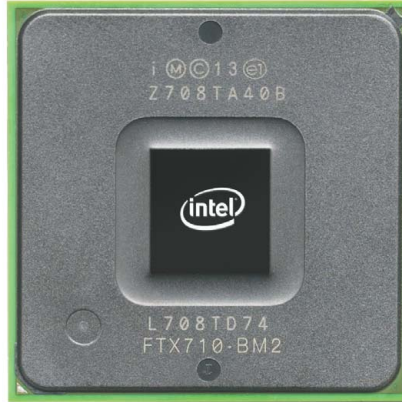
Figure 1-1. Example Component with Identifying Marks
