11th Generation Intel® Core™ Processor Family

Specification Update

Supporting 11th Generation Intel® Core™ Processor Families, Intel® Pentium® Processors, Intel® Celeron® Processors for UP3, UP3 IOT, and UP4 Platforms, formerly known as Tiger Lake

Revision 004

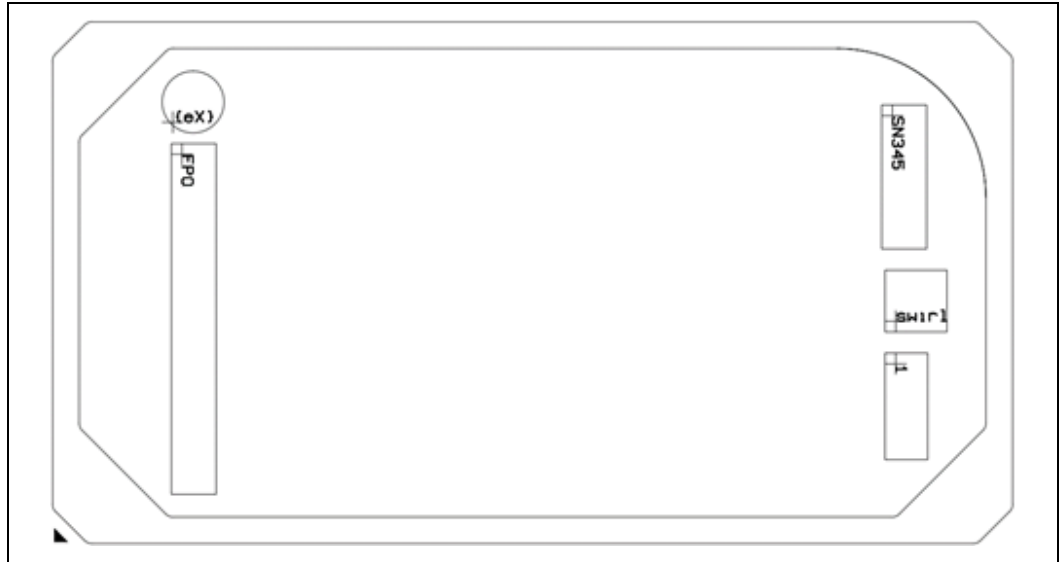
Figure 2-1. Based on UP3-Processor Line Multi-Chip Package BGA Top-Side Markings

Pin Count: 1449

Package Size: 55.5 mm x 25 mm
