10th Generation Intel® Core™ Processor

Specification Update

Supporting 10th Generation Intel® Core™ Processor Families, Intel® Pentium® Processors, Intel® Celeron® Processors for U,H and S Platforms, formerly known as Comet Lake

Revision 008

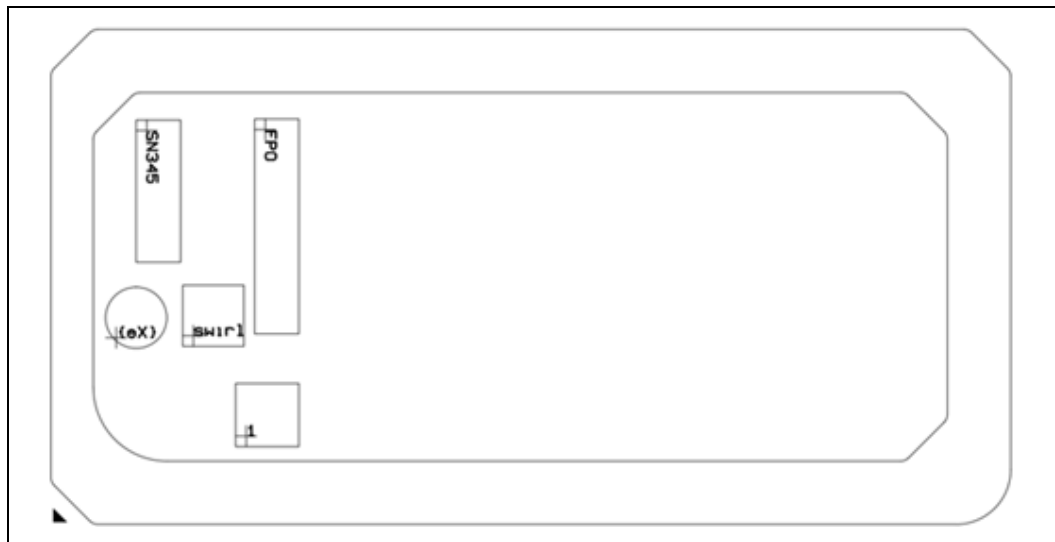
Figure 2-1. U-Processor Line Multi-Chip Package BGA Top-Side Markings

Pin Count: 1528 and Package

Size: 46 mm x 24 mm
