Intel® Pentium® Silver and Intel® Celeron® Processor

Specification Update

Formerly known as Jasperlake

Revision 0.5

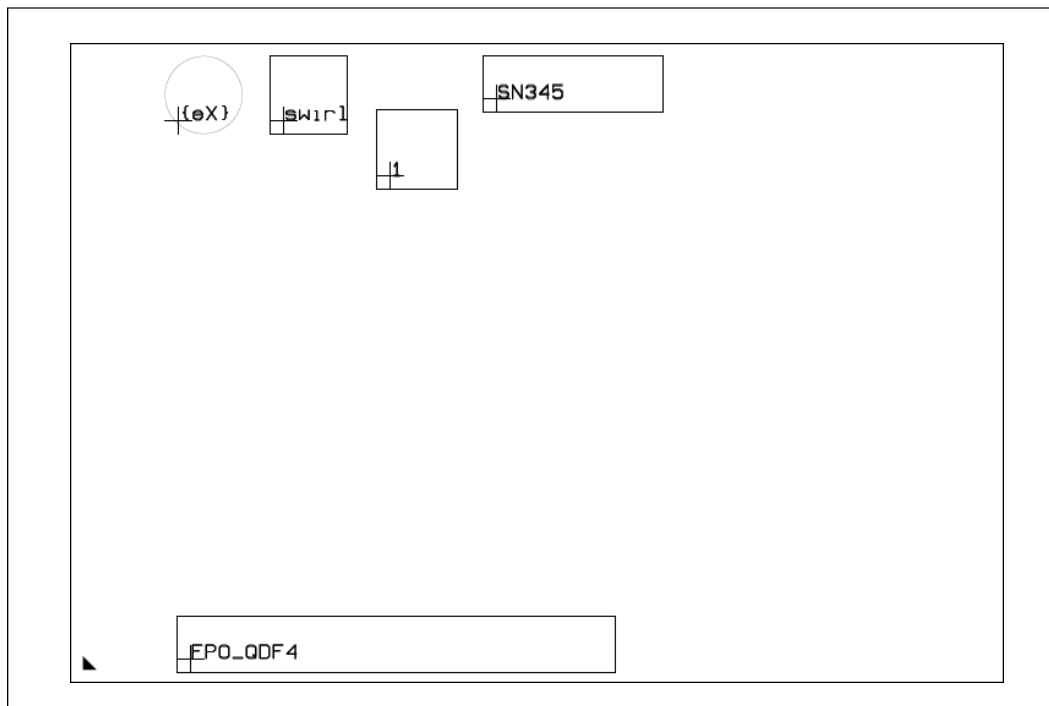
Figure 2-1. SoC Markings

Intel® Pentium® Silver and Intel® Celeron® Processors SoC is identified by the following component markings:

Pin count:1338

Package Size: 35 mm x 24 mm
