10th Generation Intel[®] Core[™] Processor Families

Specification Update

***Supporting 10th Generation Intel[®] Core[™] Processor Families,
Intel[®] Pentium[™] Processors, Intel[®] Celeron[®] Processors for
U/Y Platforms, formerly known as Ice Lake***

Revision 011

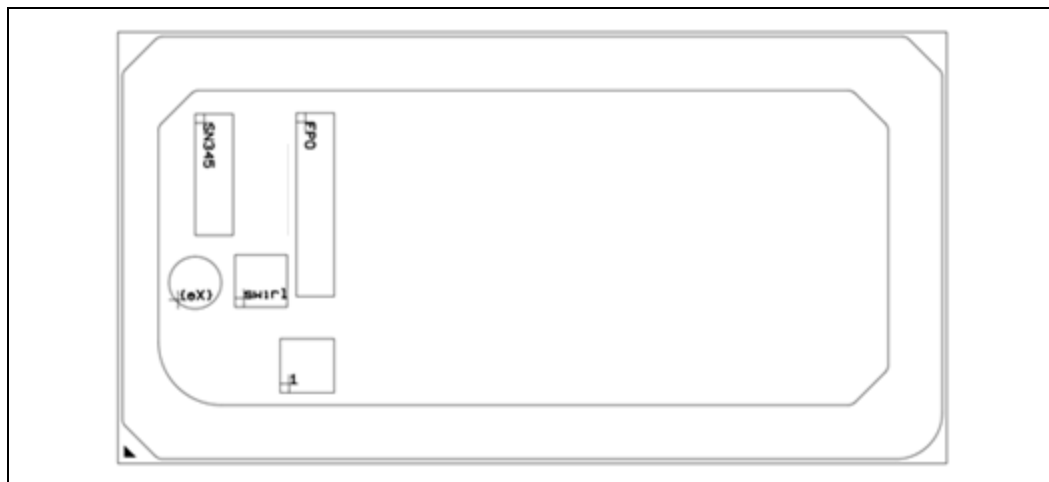
Figure 1. Based on U-Processor Line Multi-Chip Package BGA Top-Side Markings

Pin Count: 1526

Package Size: 50 mm x 25 mm

| Figure 1. Based on U-Processor Line Multi-Chip Package BGA Top-Side Markings..... | 8 |

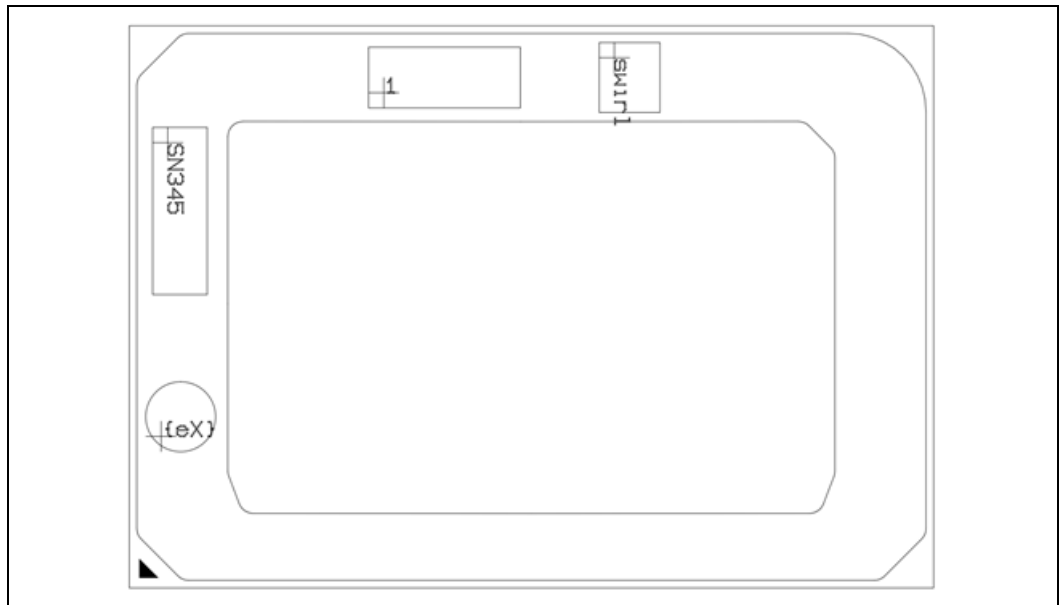
Figure 2. Based on Y-Processor Line Package BGA Top-Side Markings

Pin Count: 1377

Package Size: 26.5 mm x 18.5 mm

| Figure 2. Based on Y-Processor Line Package BGA Top-Side Markings | 9 |
