11th Generation Intel[®] Core[™] Processor Family

Specification Update

***Supporting 11th Generation Intel[®] Core[™] Processor Families,
Intel[®] Pentium[®] Processors, Intel[®] Celeron[®] Processors for
UP3, UP3 IOT, UP4, H35, and H81 Platforms, formerly known
as Tiger Lake***

Revision 010

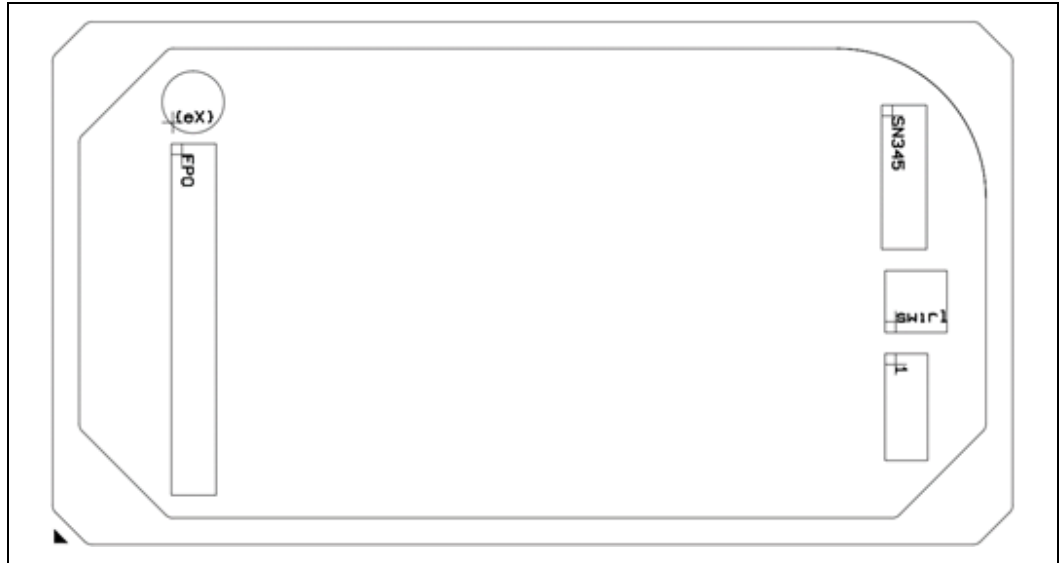
Figure 1. Tiger Lake Processor Based on UP3/H35-Processor Line Multi-Chip Package BGA Top-Side Markings

Pin Count: 1449

Package Size: 55.5 mm x 25 mm

Production (SSPEC):

- FPO: FPOxxxxx
- {eX}
- SWIR1: Intel® logo

Note: "1" is used to extract the unit visual ID (2D ID).
