11th Generation Intel[®] Core[™] Processor

Specification Update

***Supporting 11th Generation Intel[®] Core[™] Processor for S
Processor Line Platforms, formerly known as Rocket Lake***

Revision 007

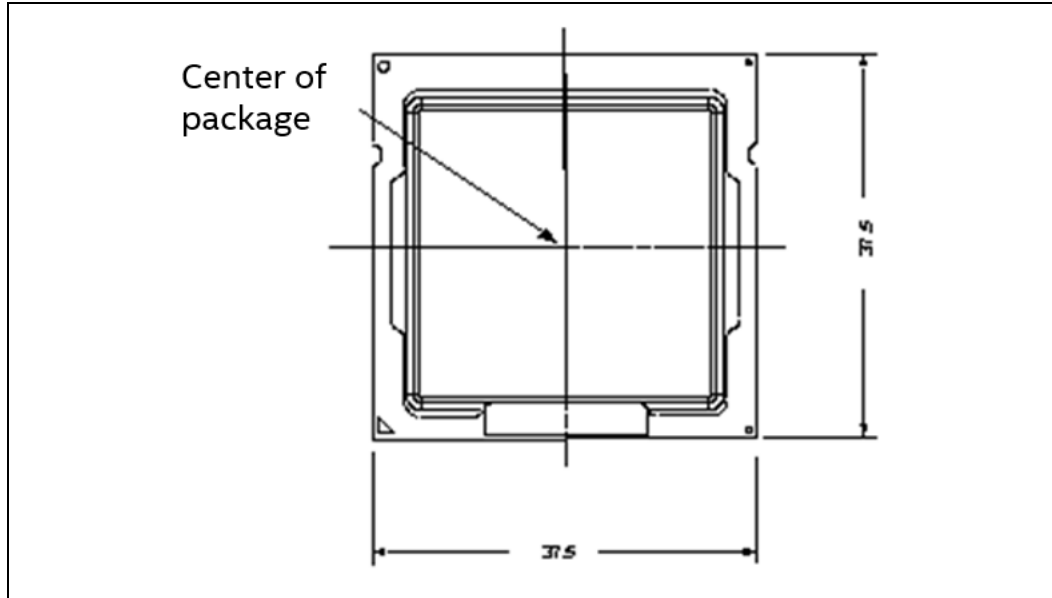
Figure 1. S-Processor Line Multi-Chip Package LGA Top-Side Markings

Pin Count: 1200

Package Size: 37.5 mm x 37.5 mm

Figure 1. S-Processor Line Multi-Chip Package LGA Top-Side Markings.....	8
--	---
